U.S. Department
of Transportation
**National Highway
Traffic Safety
Administration**

DOT HS 811 862

November 2013

Motorcoach Side Glazing Retention Research

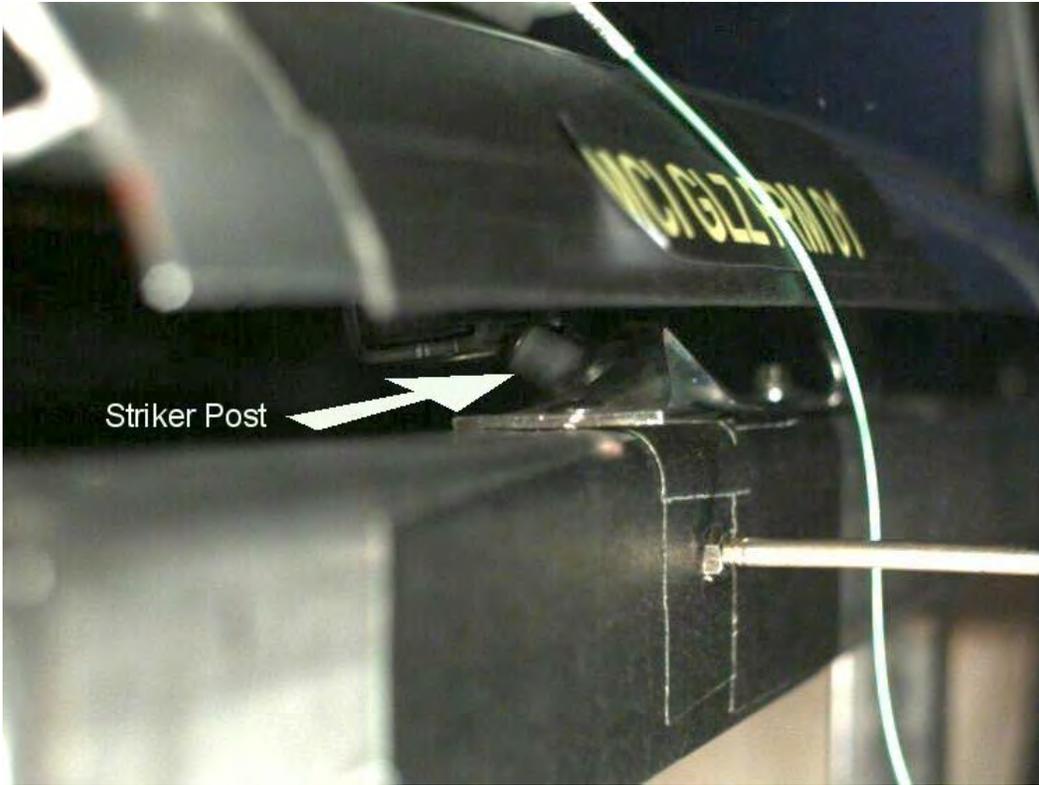
Figure 5.14 MCI E/J-Series Unlatching Event at Primary Latch

Figure 5.1 shows the results of each motorcoach type grouped according to whether the window remained latched or unlatched for tests conducted near the primary latch. Shaded bands are overlaid to show the transition velocity where unlatching occurs. That transition speed for the MCI E/J-series was in the 15 - 16 km/h range. Unlatching occurred by one of two slightly different events. In some of the tests, the primary latch's detent lever, under impact loading, transferred a force great enough to deform the striker plate and unseat the striker post from the plate. The post rotated in the direction of impact allowing the lever to slide over the post as seen in Figure 5.14. In other tests, the latch bar rotated upward during the impact event, which opened the primary latch's detent lever prior to the lever sliding over the post.

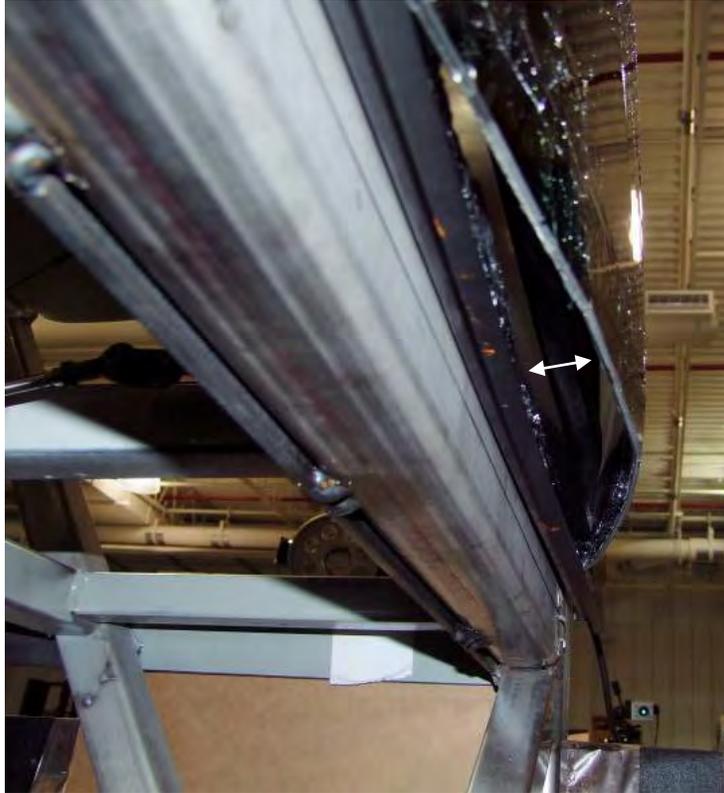
Figure 5.15 Laminate Material Separated From Window Frame

High speed video analysis showed that the primary latch's detent lever nearly slid over the striker post in test MCI GLZ FRM 05, conducted at 18 km/h, and the post-test inspection revealed that the detent lever on the secondary latch was in the open position. MCI GLZ FRM 11 repeated the test conditions and unlatching was observed at both latches. In test MCI GLZ FRM 07, conducted at 19 km/h, the glazing material separated from the frame at the bottom of the window as shown in Figure 5.15. This reduced the energy imparted on the latching mechanisms, and the window remained latched. Test MCI GLZ FRM 09 was run to repeat the conditions of MCI GLZ FRM 07. The glazing material and bonding remained intact. The detent lever on the primary latch slid over the latch plate post and opened on the secondary latch during the impact event, allowing the window to swing open.

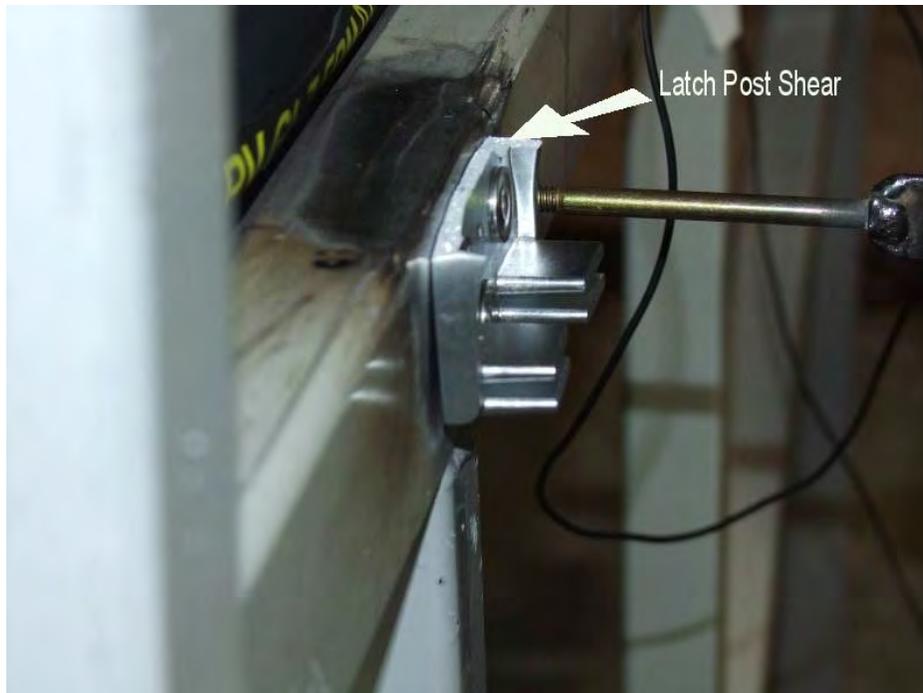
Figure 5.16 Prevest Primary Latch Post Shear Failure

The transition velocity for the Prevest window was 14 km/h. Three different failure modes were seen in this latch design which resulted in the window unlatching. In tests PV GLZ FRM 01, PV GLZ FRM 07, and PV GLZ FRM 08, the top of the primary latch post sheared off due to loading of the latch bar. An example of this failure is shown in Figure 5.16. In test PV GLZ FRM 02, the composite latch bar tore along the top perforated surface, as shown in 5.17, while in test PV GLZ FRM 03 the latch bar also tore along this surface and separated from the window frame. The windows remained latched in the two tests conducted at the center positions. The inner tempered glass ply completely shattered in test PV GLZ FRM 09, conducted at the center of the latching mechanisms at 21.6 km/h.

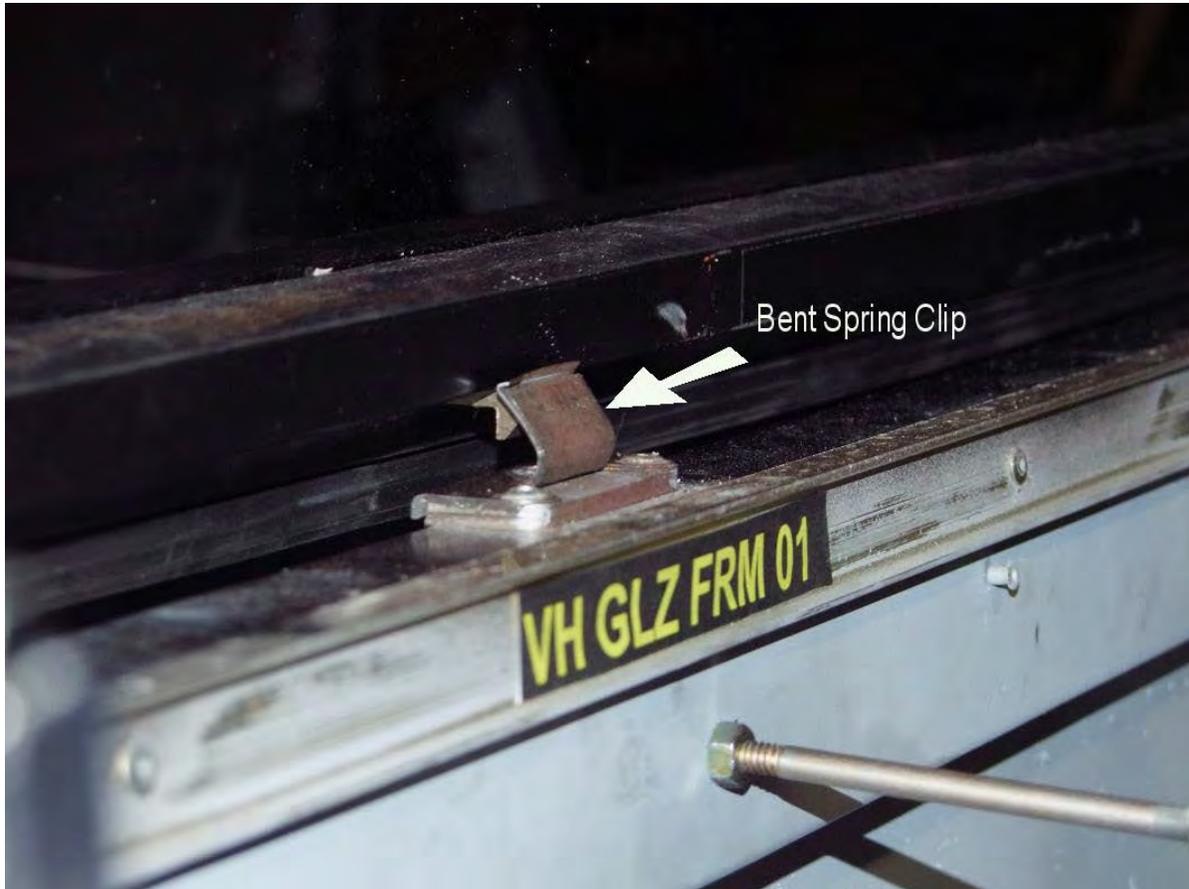
Figure 5.18 Van Hool Primary Latch Spring Clip Failure

emergency handle. Unlatching occurred when the spring clips bent backward during the impact, as seen in Figure 5.18, allowing the window to open. The spring clip design offered less resistance than other latch designs, and the transition velocity for unlatching was in the 11 - 13 km/h range.

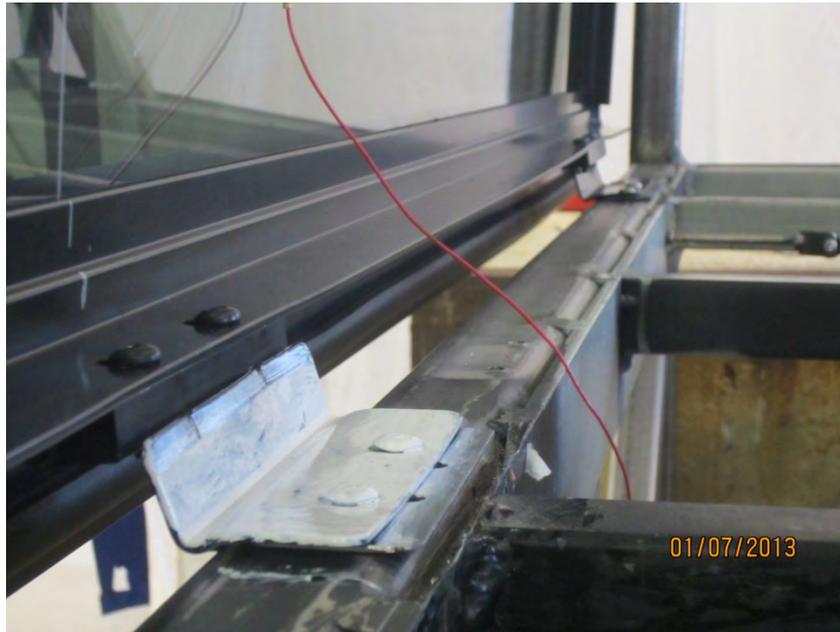
Figure 9.2 Failure of Retaining Clips Resulting in Window Opening

retaining clip, the primary clips (near the impact location) bent backwards. The secondary clips (the non-impacted retaining clips) bent but did not release, allowing the window to only partially open. For tests conducted at the center of the daylight opening on unbroken glazing, the retaining clips bent, but the window opening result depended on the type of glazing impacted. The single-glazed window fully opened, but the double-glazed window did not open. For tests conducted at the center of the daylight opening on pre-broken double-glazed windows, there was no damage to the retaining clips, and the windows did not open.
